**FORMAL INVESTIGATION INTO THE CIRCUMSTANCES SURROUNDING THE
ALLISION BETWEEN THE BARGE TOW OF THE M/V BROWN WATER V AND
THE QUEEN ISABELLA CAUSEWAY BRIDGE ON SEPTEMBER 15, 2001, IN PORT
ISABEL, TEXAS, RESULTING IN MULTIPLE LOSS OF LIFE**

ACTION BY THE COMMANDANT

**INVESTIGATION REPORT INTO THE CIRCUMSTANCES SURROUNDING
THE ALLISION BETWEEN THE BARGE TOW OF THE M/V *BROWN WATER*
V AND THE QUEEN ISABELLA CAUSEWAY BRIDGE, TEXAS, ON 15
SEPTEMBER 2001, RESULTING IN MULTIPLE LOSS OF LIFE**

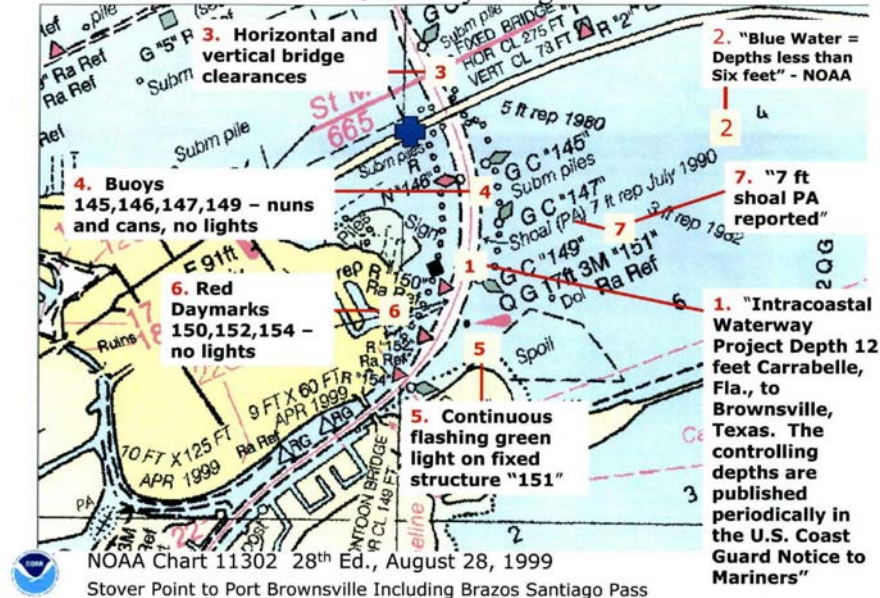
Charting Features in Vicinity of Queen Isabella Causeway Bridge

10.5 The Army Corps of Engineers conducted a post-casualty channel survey (including areas outside of the channel) on September 15. The survey found the channel to be the proper depth and width and the aids to navigation, as displayed on the nautical chart, in their proper positions.

10.6 On September 25 the National Oceanic and Atmospheric Administration conducted a hydrographic survey of the channel between the Long Island Swing Bridge and the Queen Isabella Causeway Bridge. The results of the Army Corps of Engineers survey and the National Oceanic and Atmospheric Administration mirrored each other.
